CONSERVATION BEFORE & AFTER PHOTOS 2019

COLORADO MOUNTAIN CLUB
ONLINE UNIVERSITY

Before & After

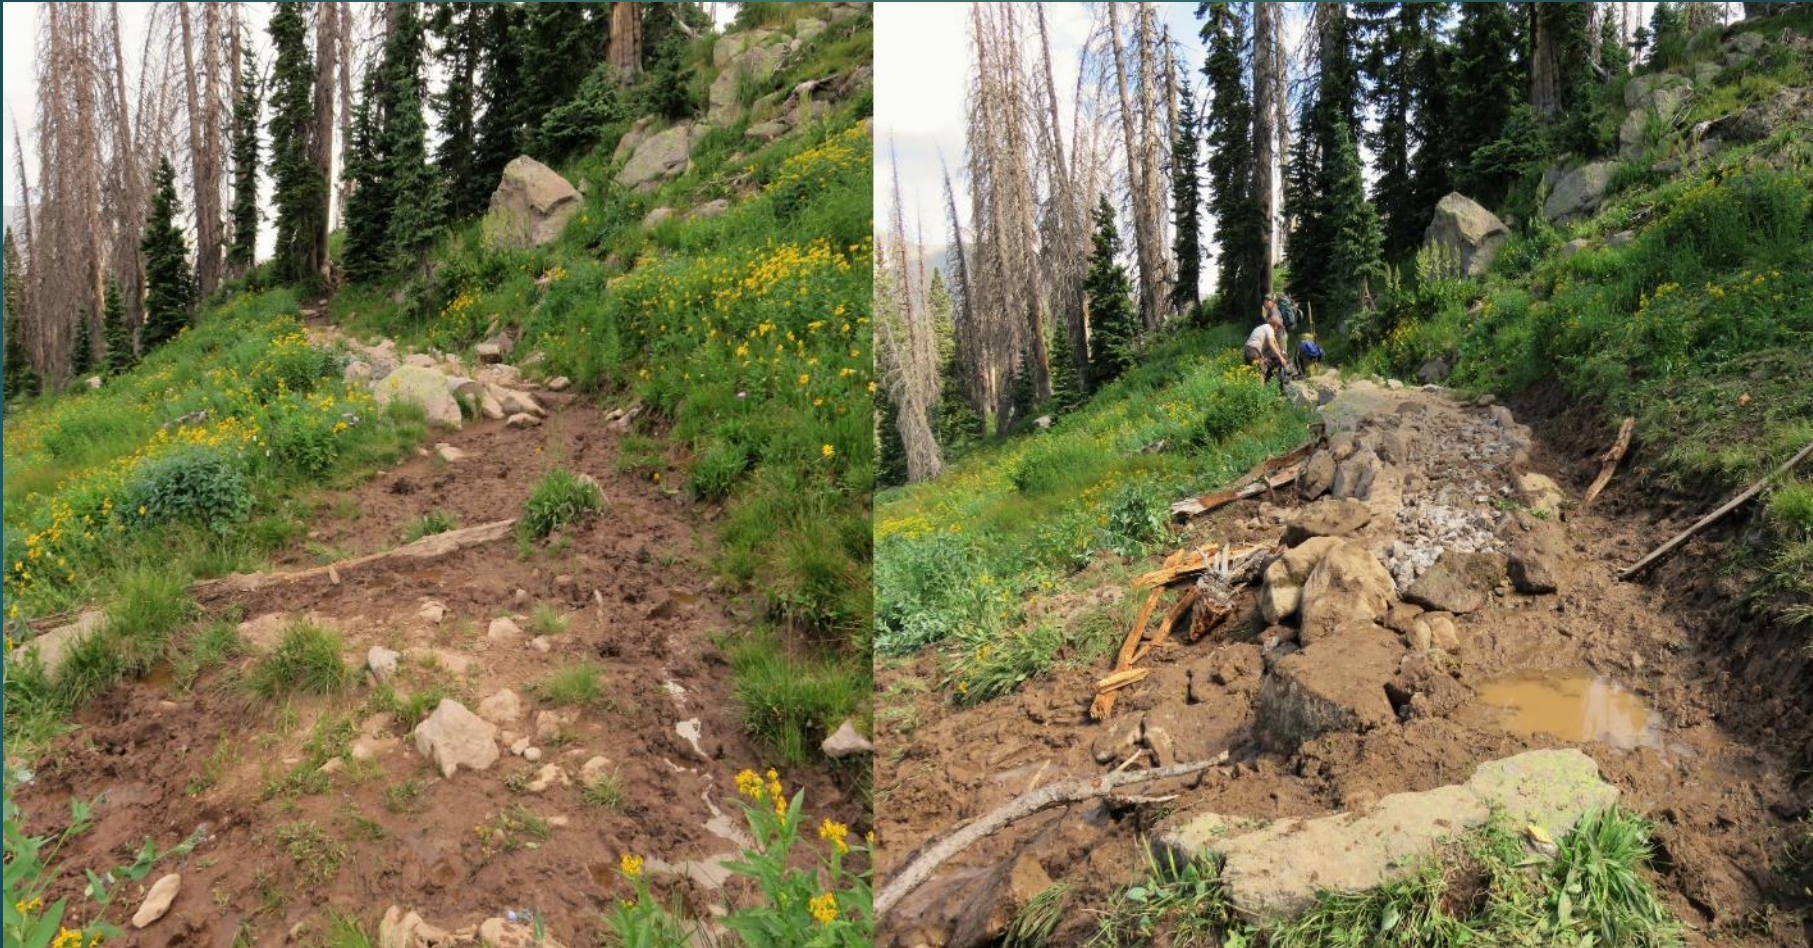
This is on the Continental Divide Trail just north of Wolf Creek Pass. Work was done over two weeks to create a large armored drainage structure.

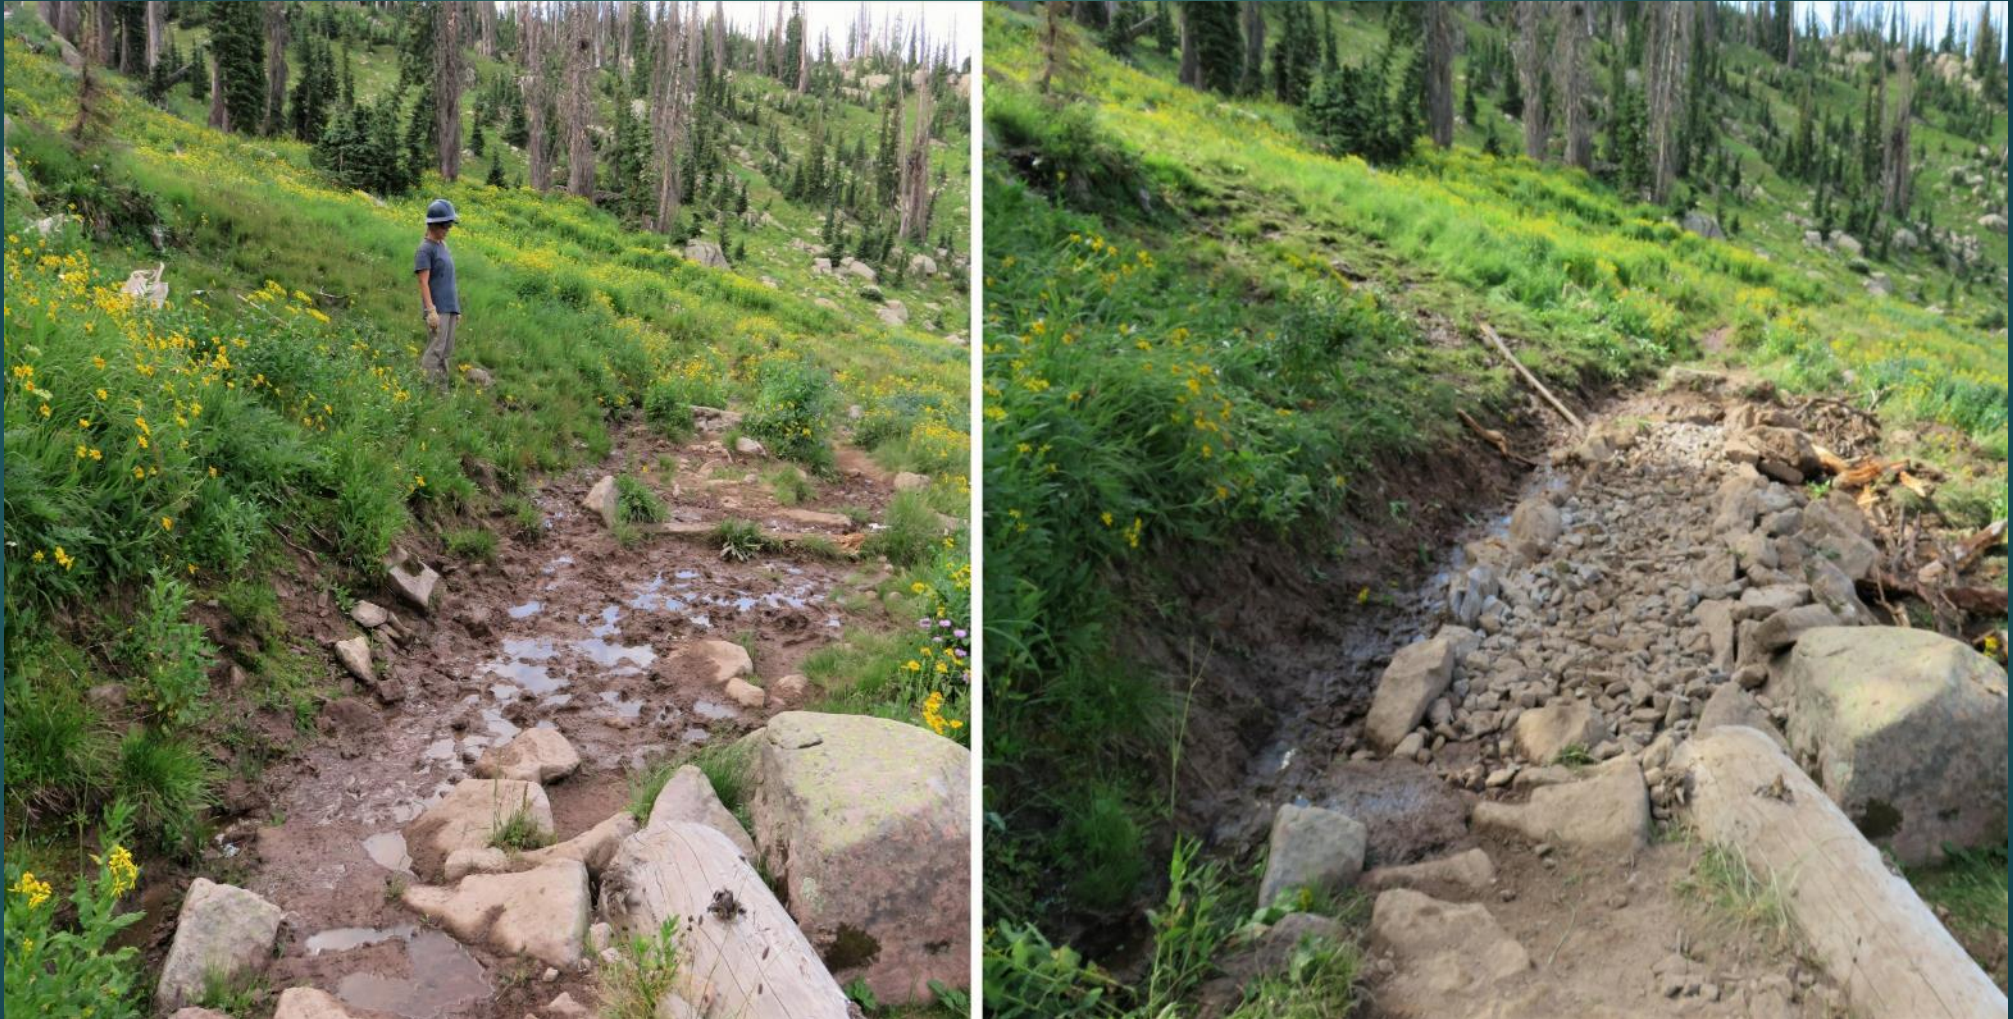
This is the same structure from the other end.

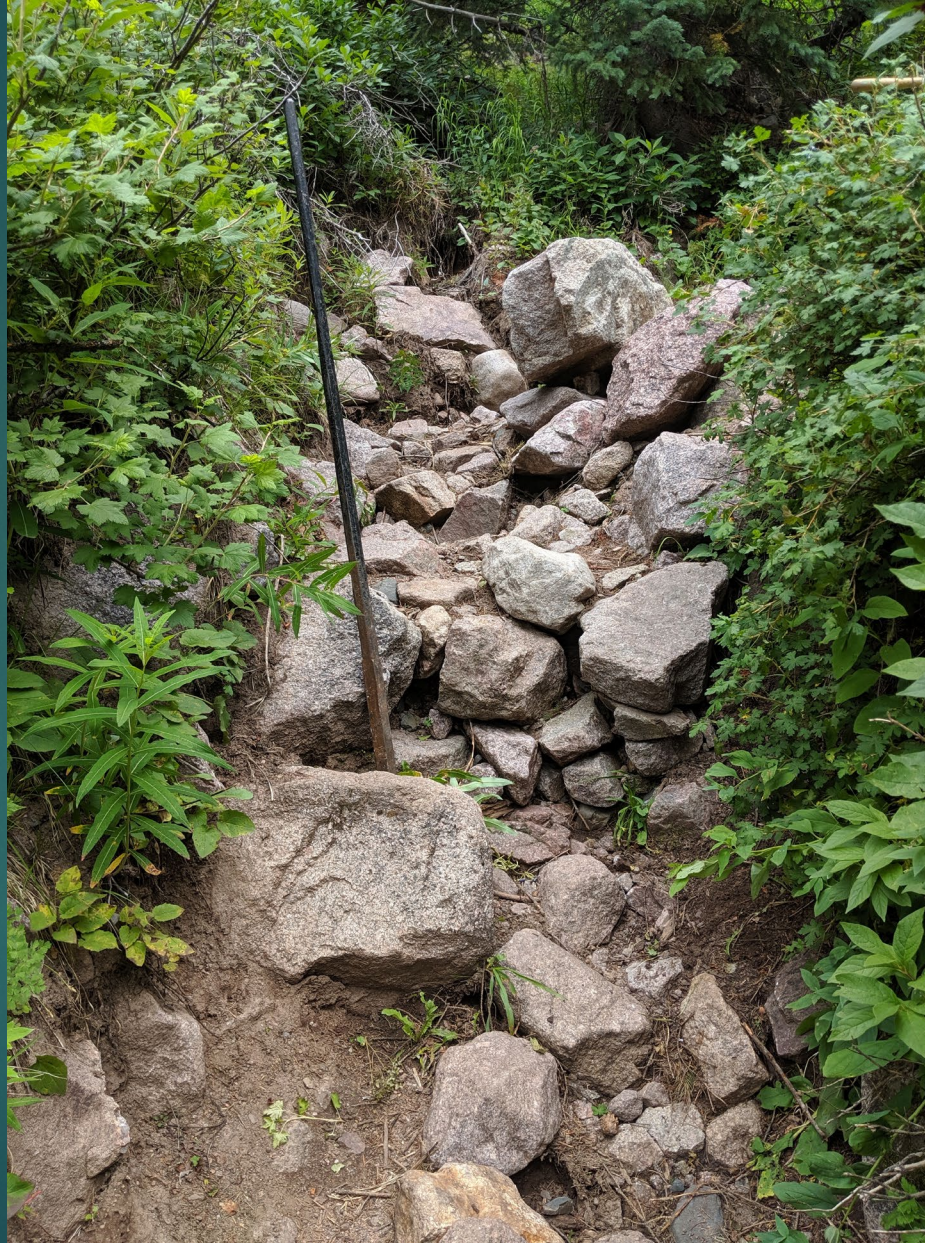
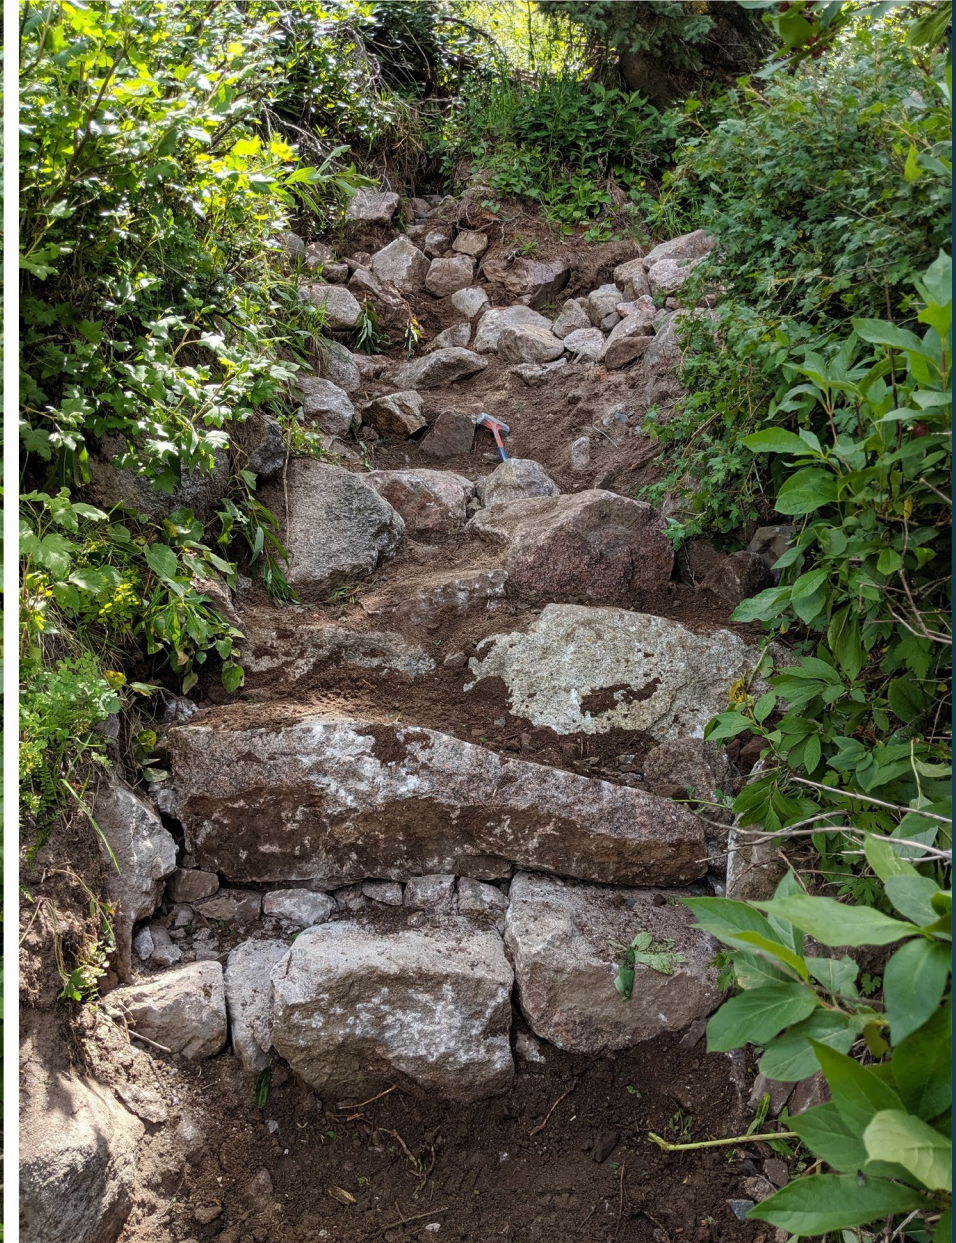
- ▶ On the Cataract Gulch Trail near Lake City, the crew repositioned rocks to make a more sustainable and easy path. Something to consider is the character of the trail in total. If the crew put in pristine rock stairs it would stick out from the rest of this trail, which is fairly “rustic”.

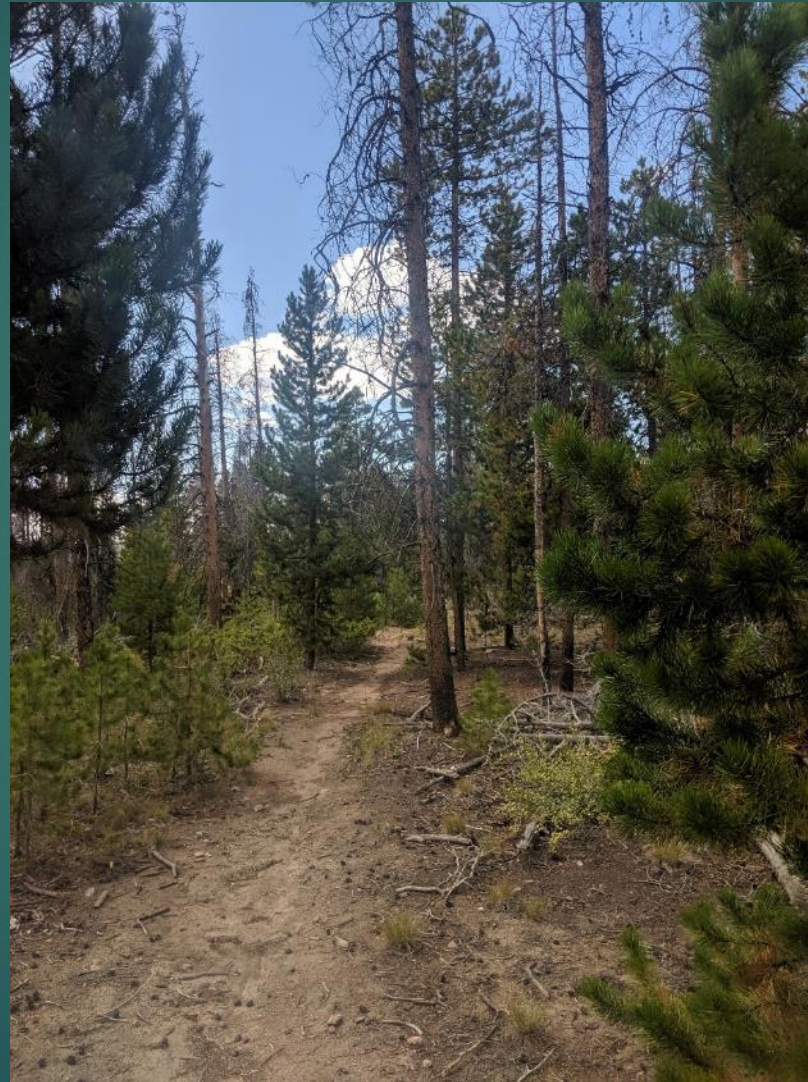
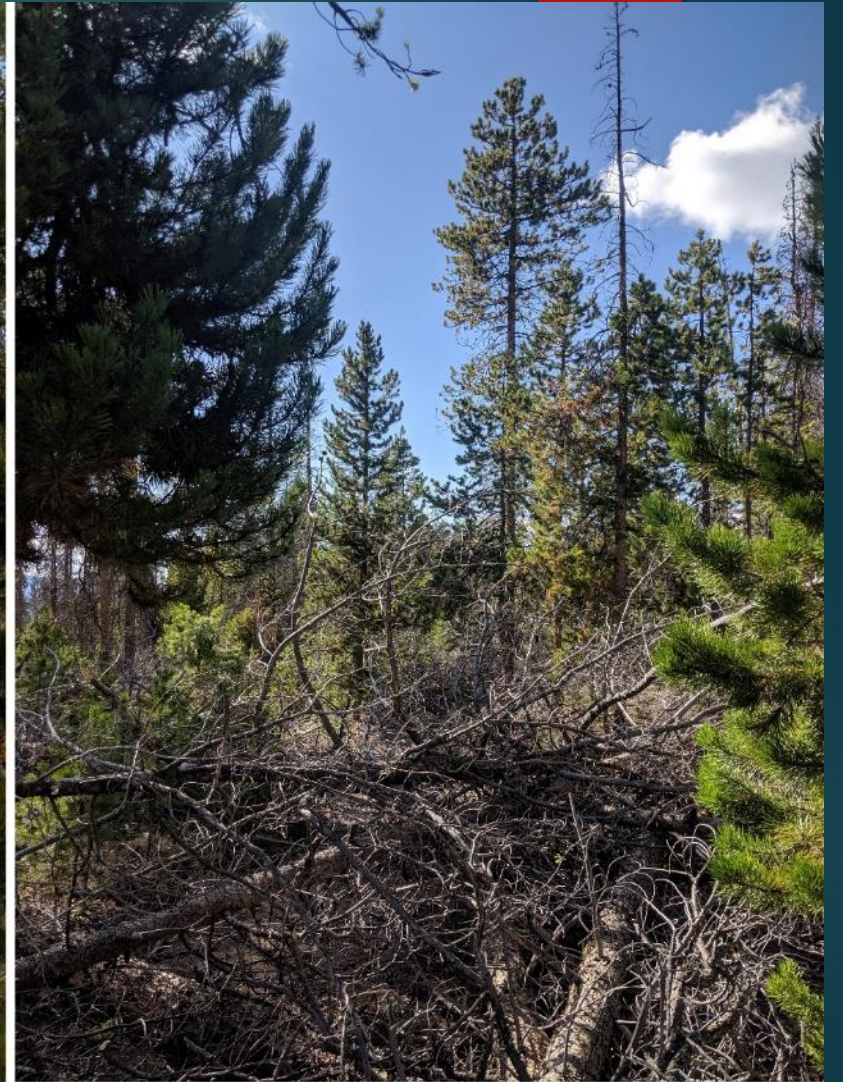
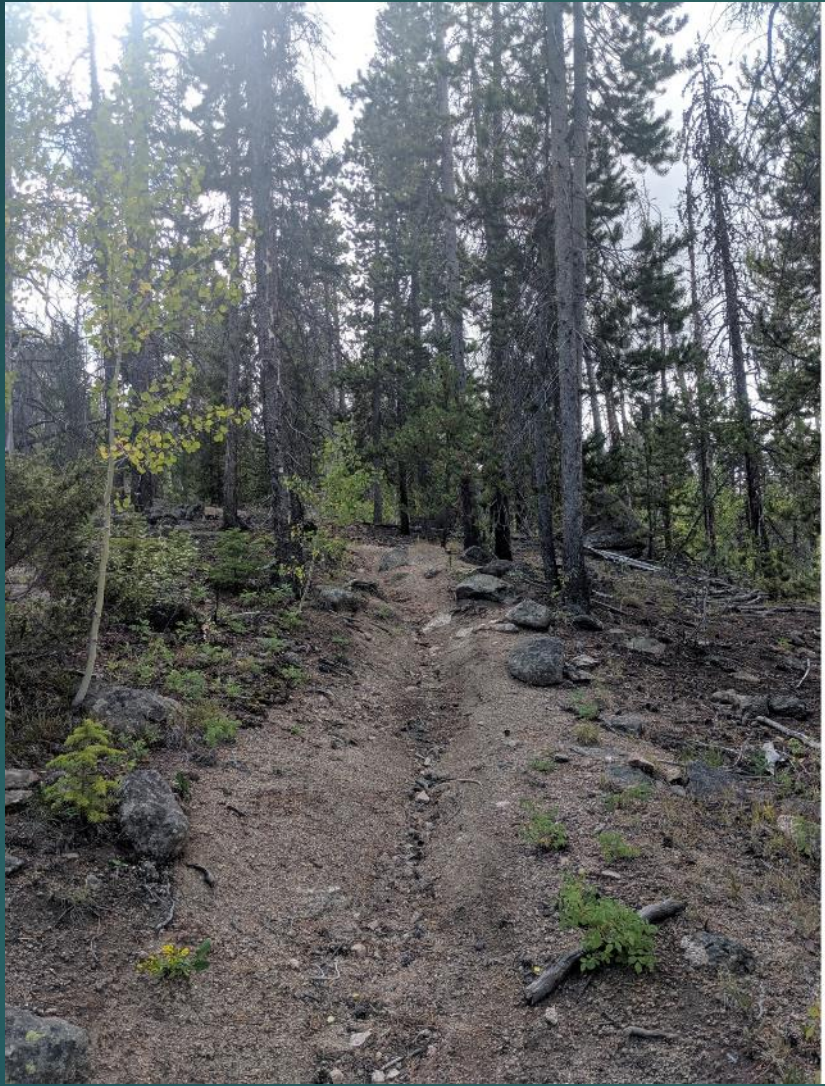
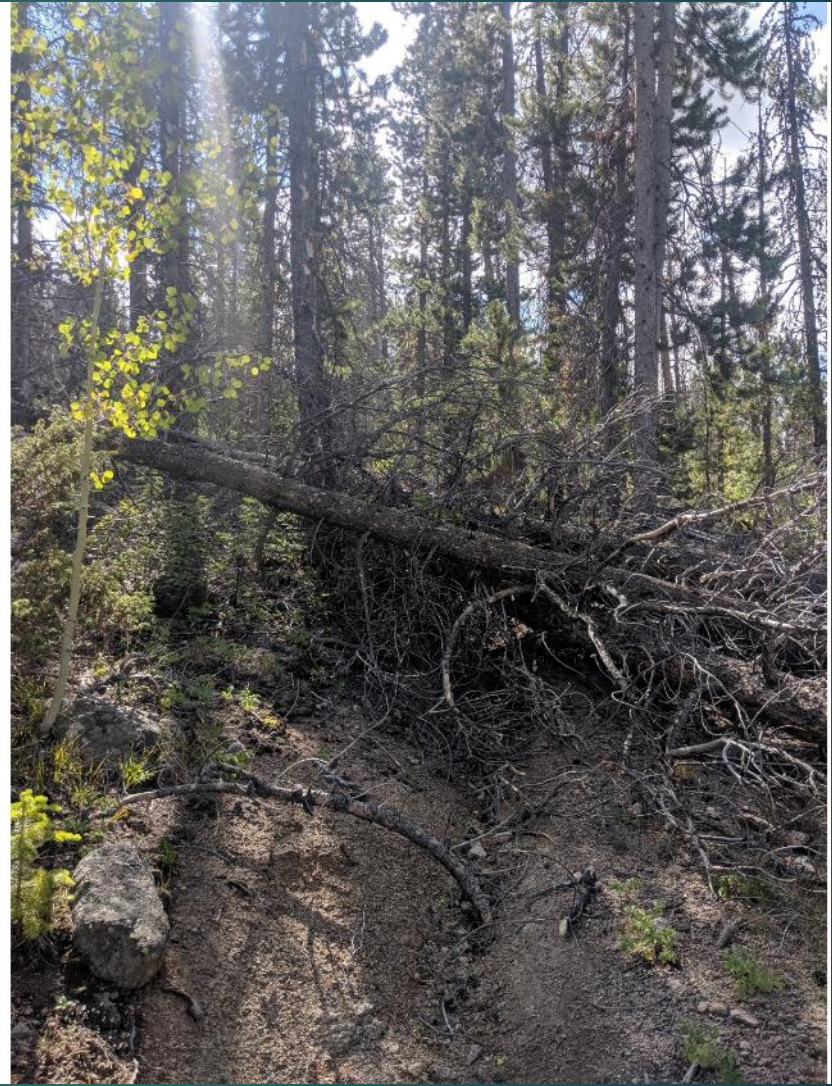
- ▶ These next two photos might look like they are in the wrong order, but they are from a restoration project near Tabernash. This old trail had been previously closed at the entrances, but people were still using it. The crew helped to more permanently close this trail by dropping standing dead trees across the trail

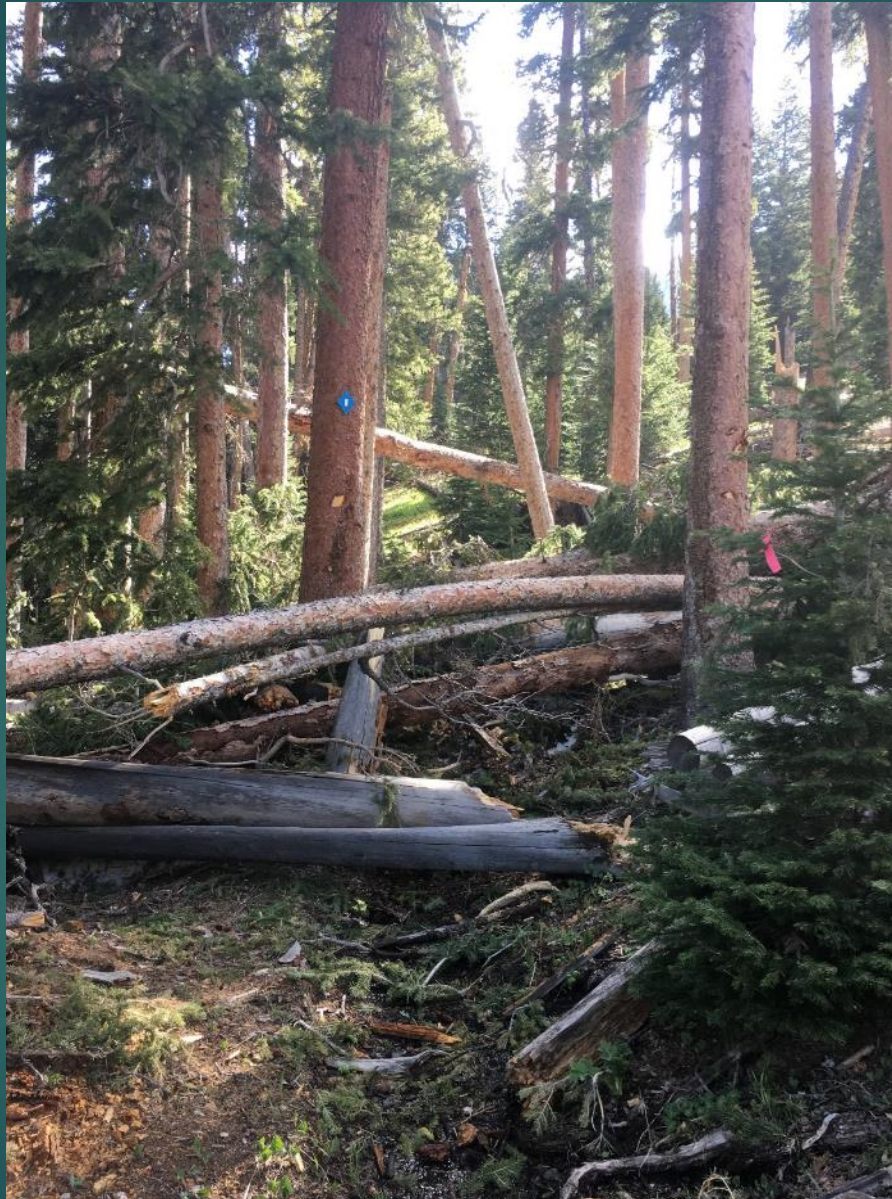
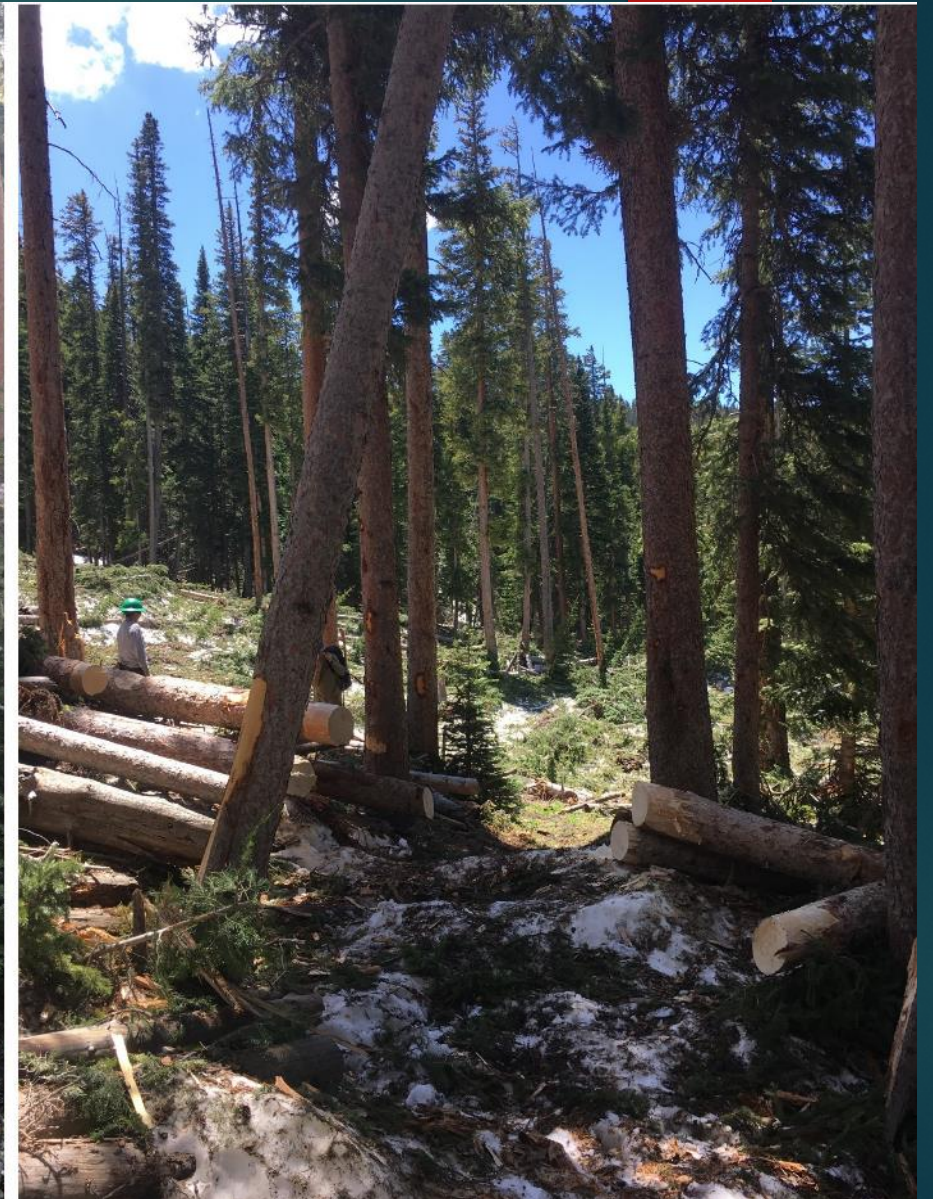
- This picture shows some of the trees piled up from the historic avalanche cycle in 2019. The Dallas Trail near Ouray was hit especially hard. If trails are not logged out immediately after events like this they often become inundated with downed trees and become impassable.

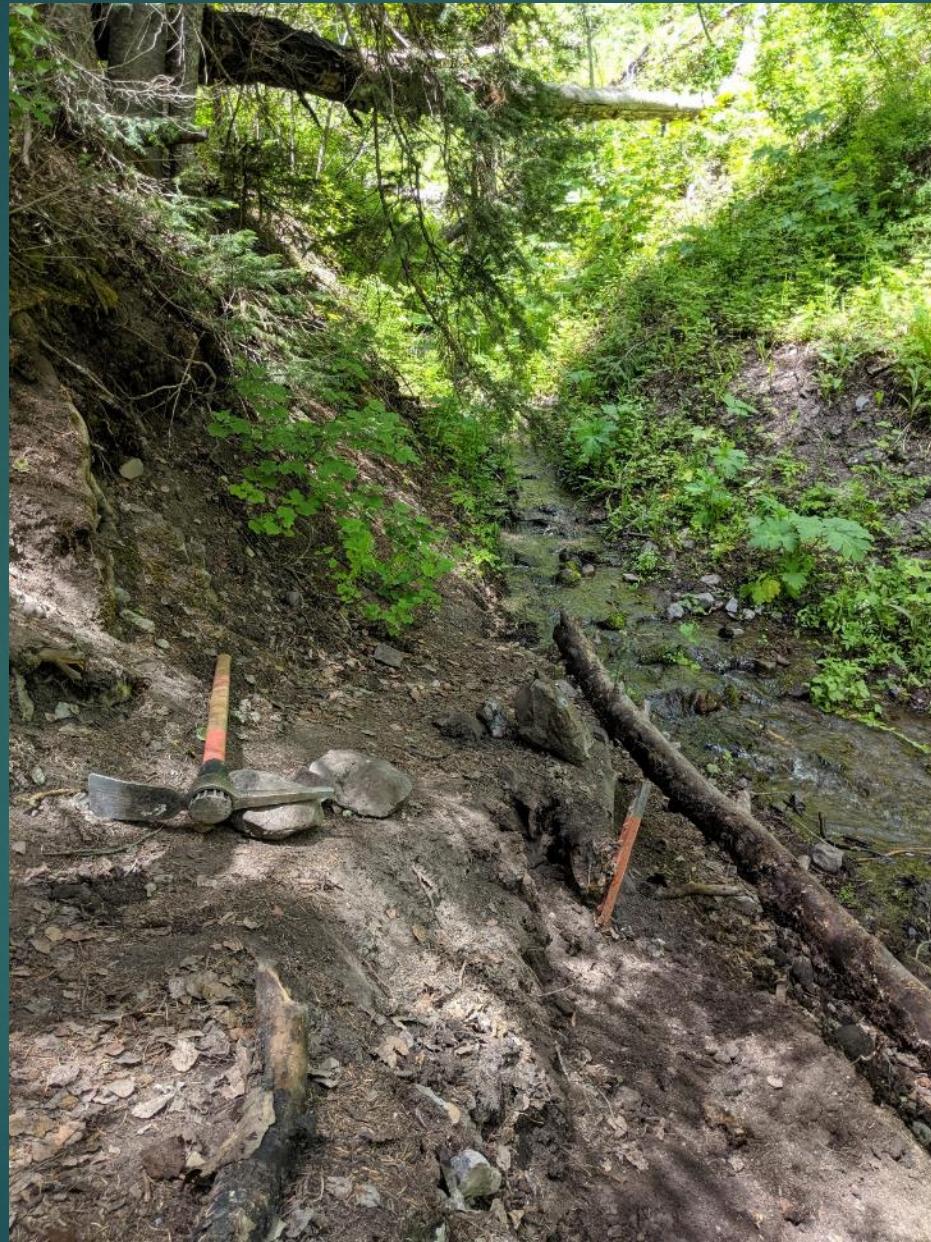
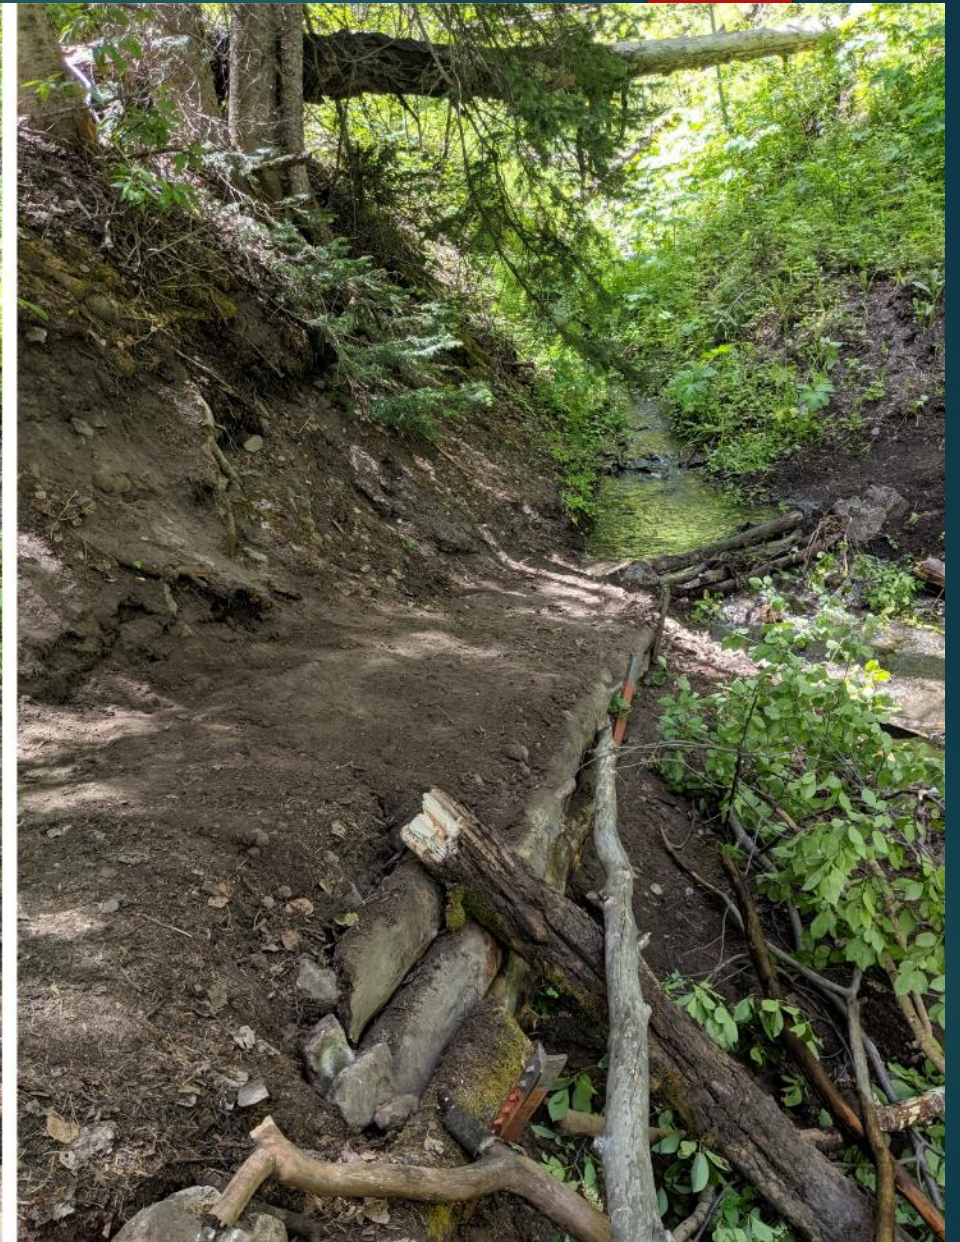
- On the other end of the Dallas Trail, a section of retaining wall had failed and the crew worked to rebuild it using available materials.

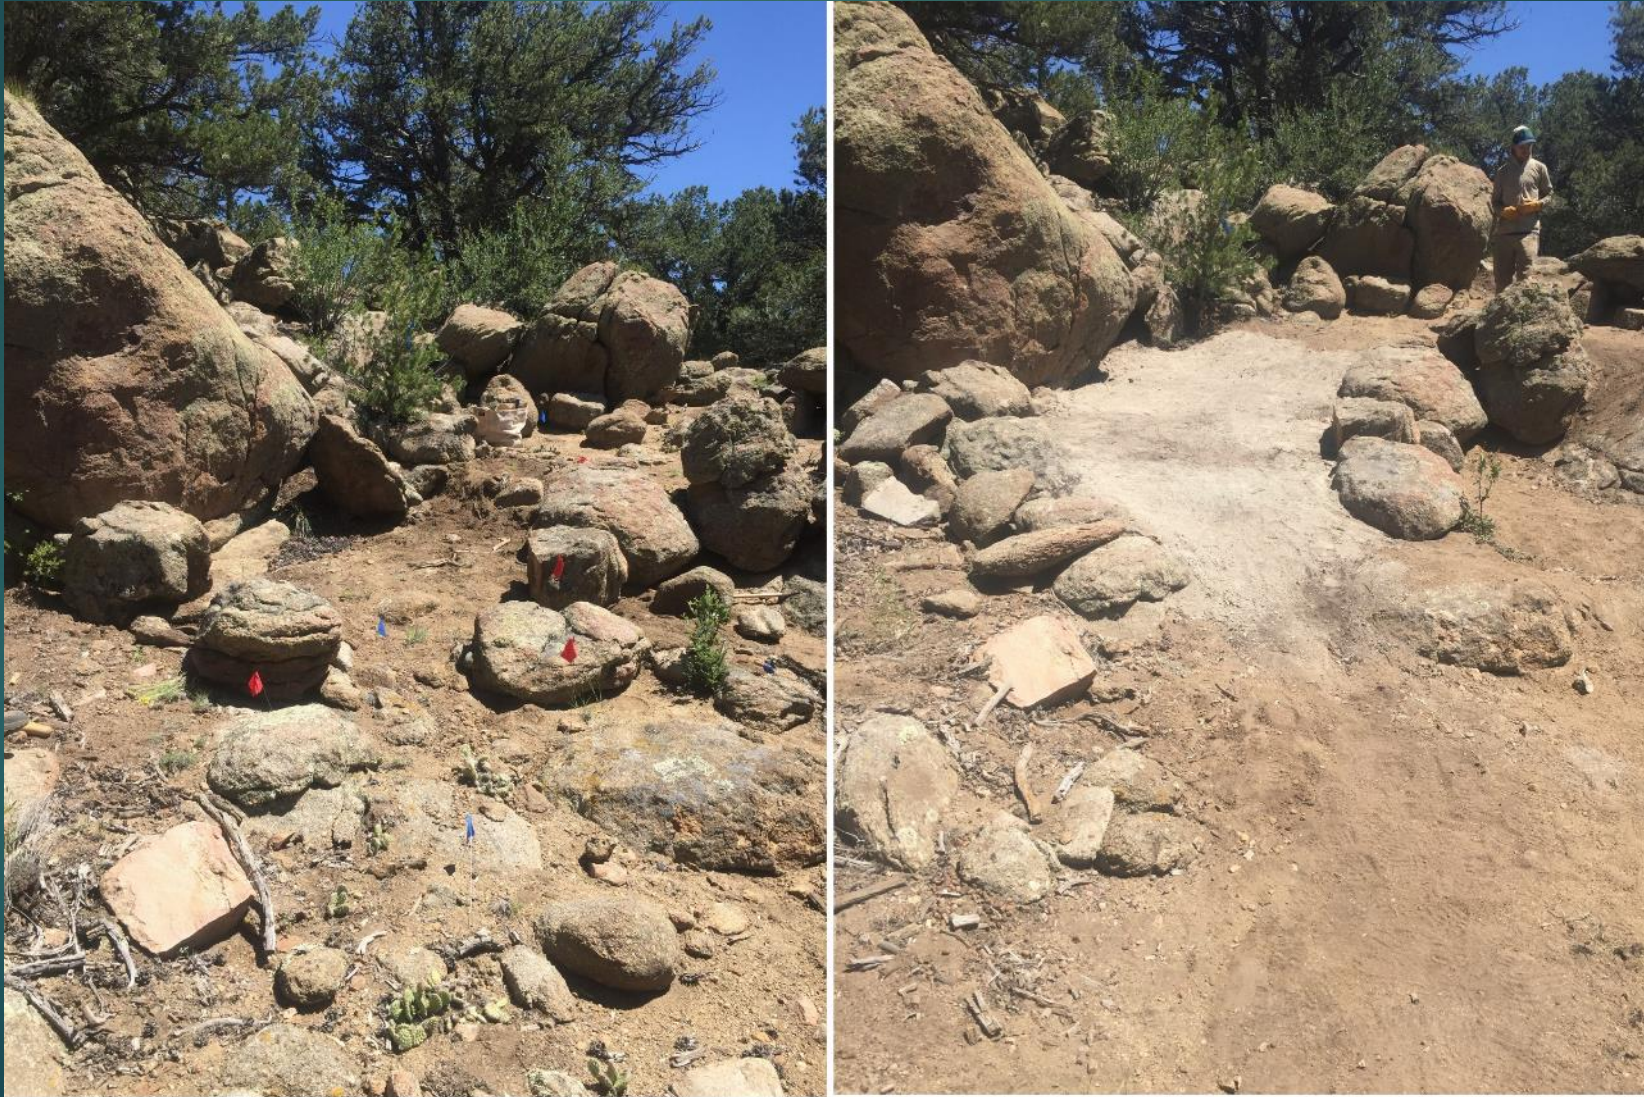
- These pictures are from a new trail construction project near Buena Vista. This section of trail had a large ramp structure created to make the section more user friendly.

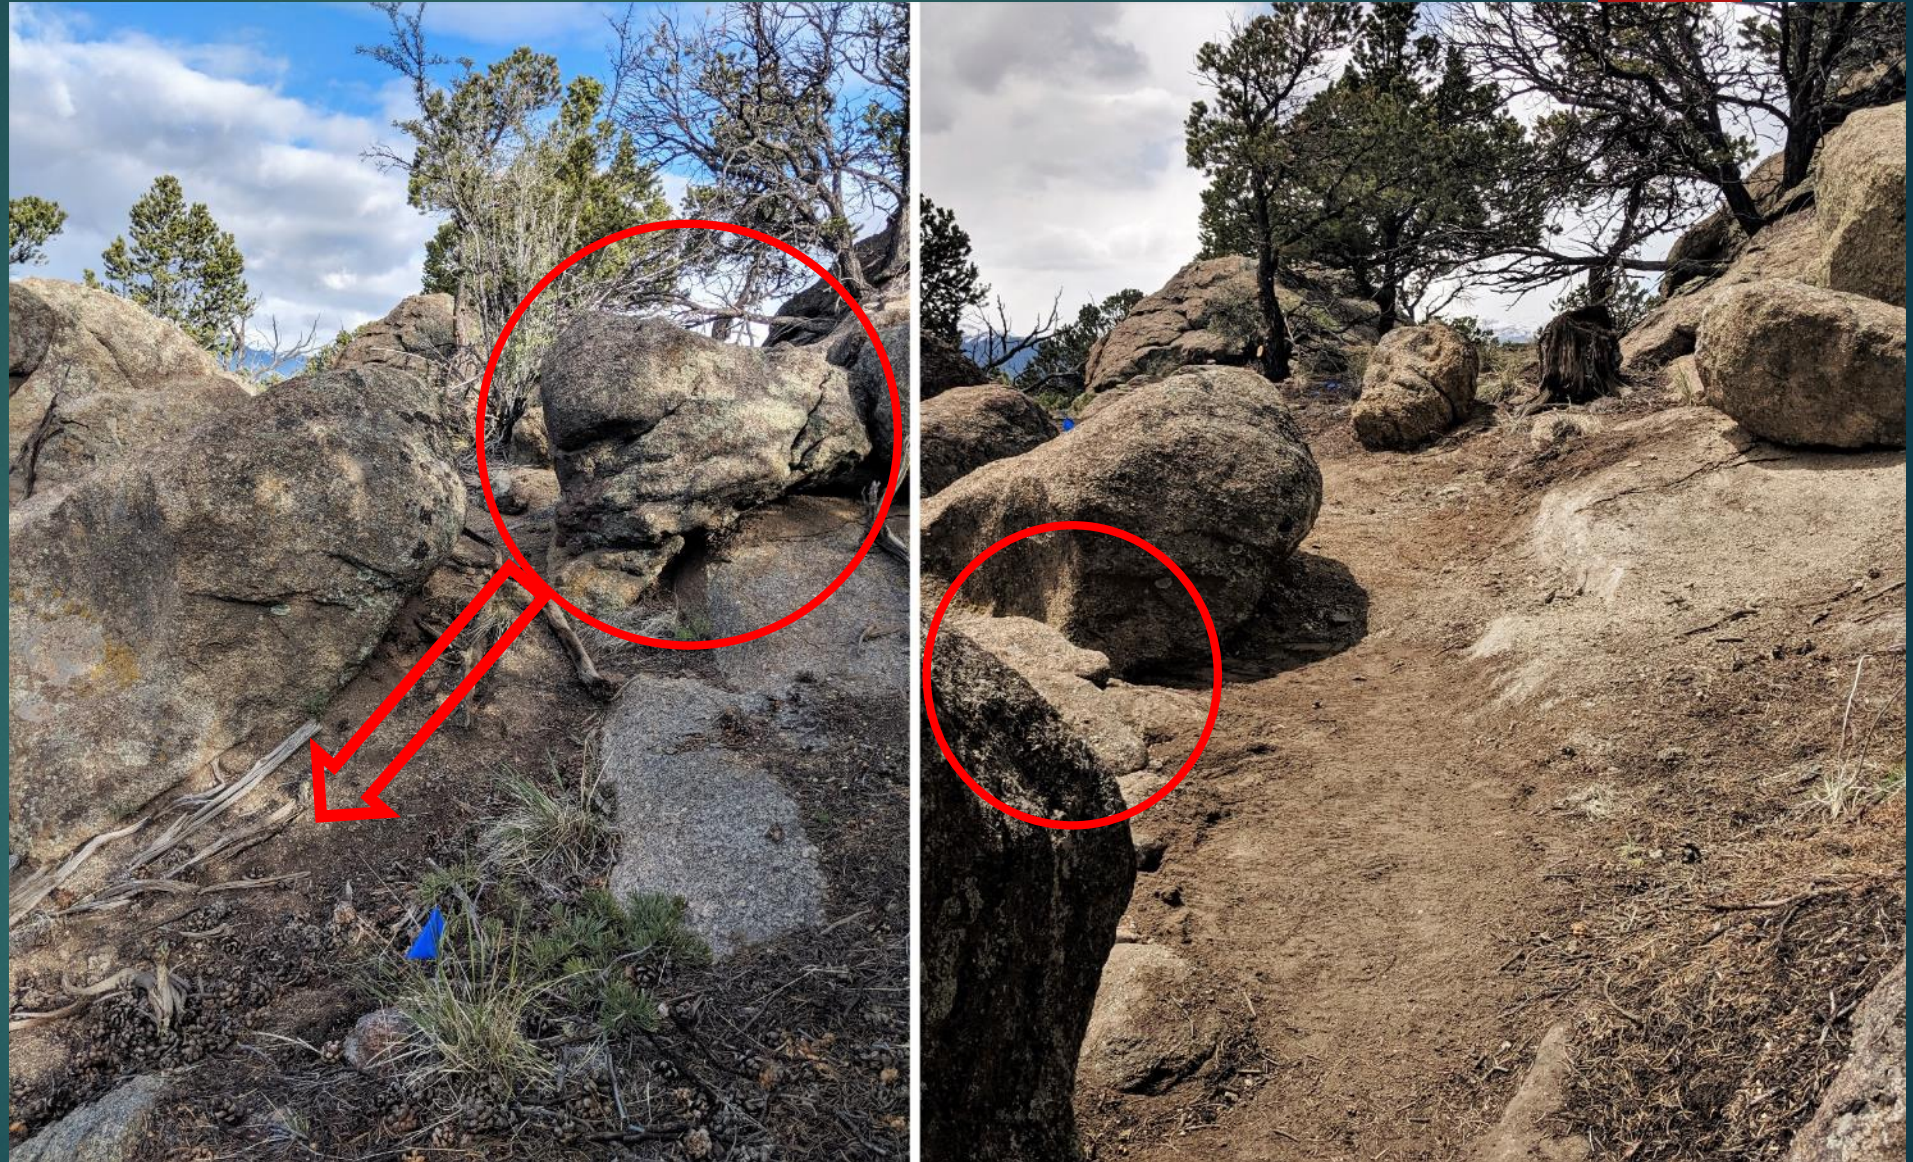
- Camp Elevation was a new trail construction project in 2019. The rock circled in red was moved to create more width and ended up being an important part of retaining the tread material.

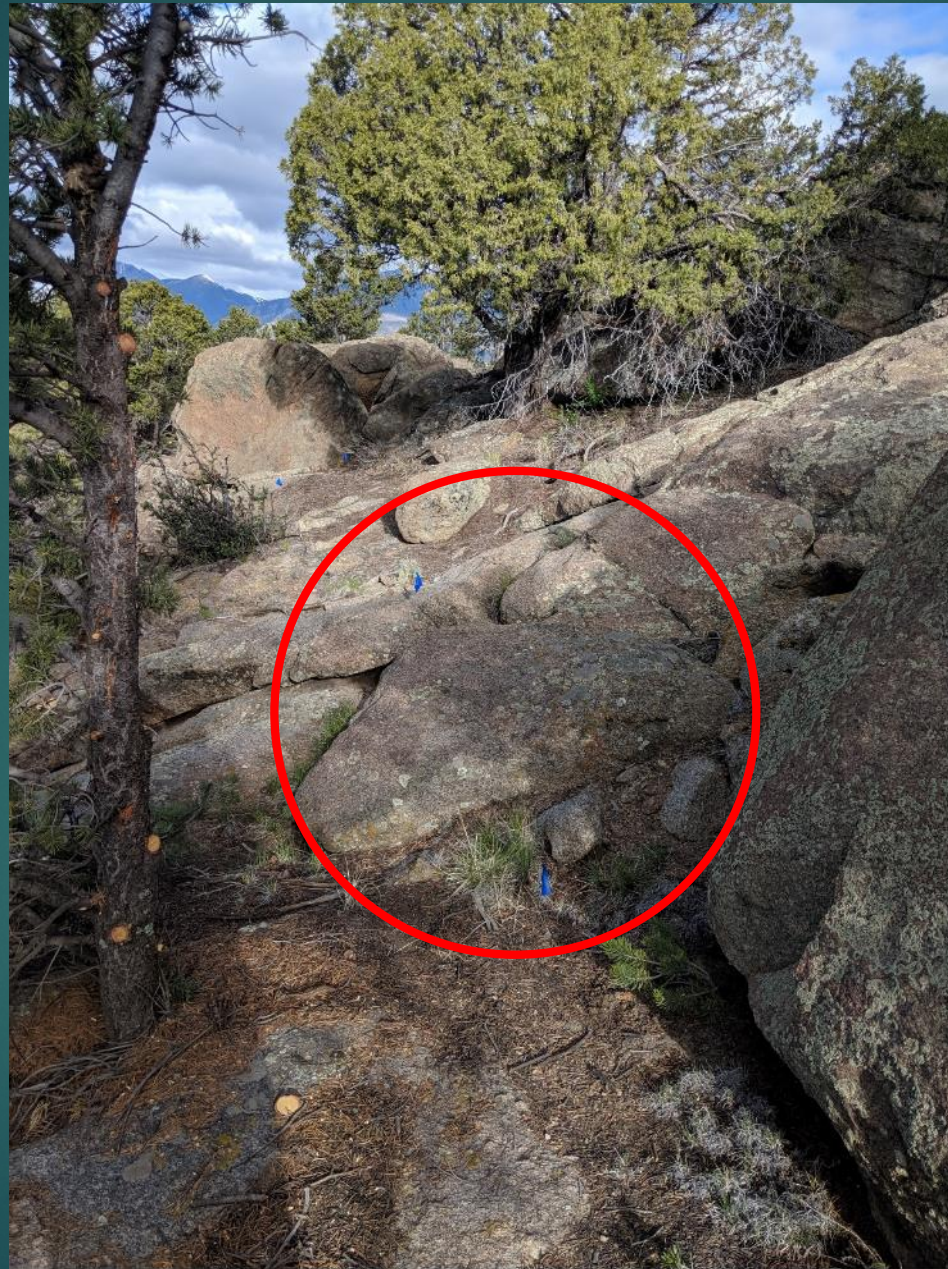
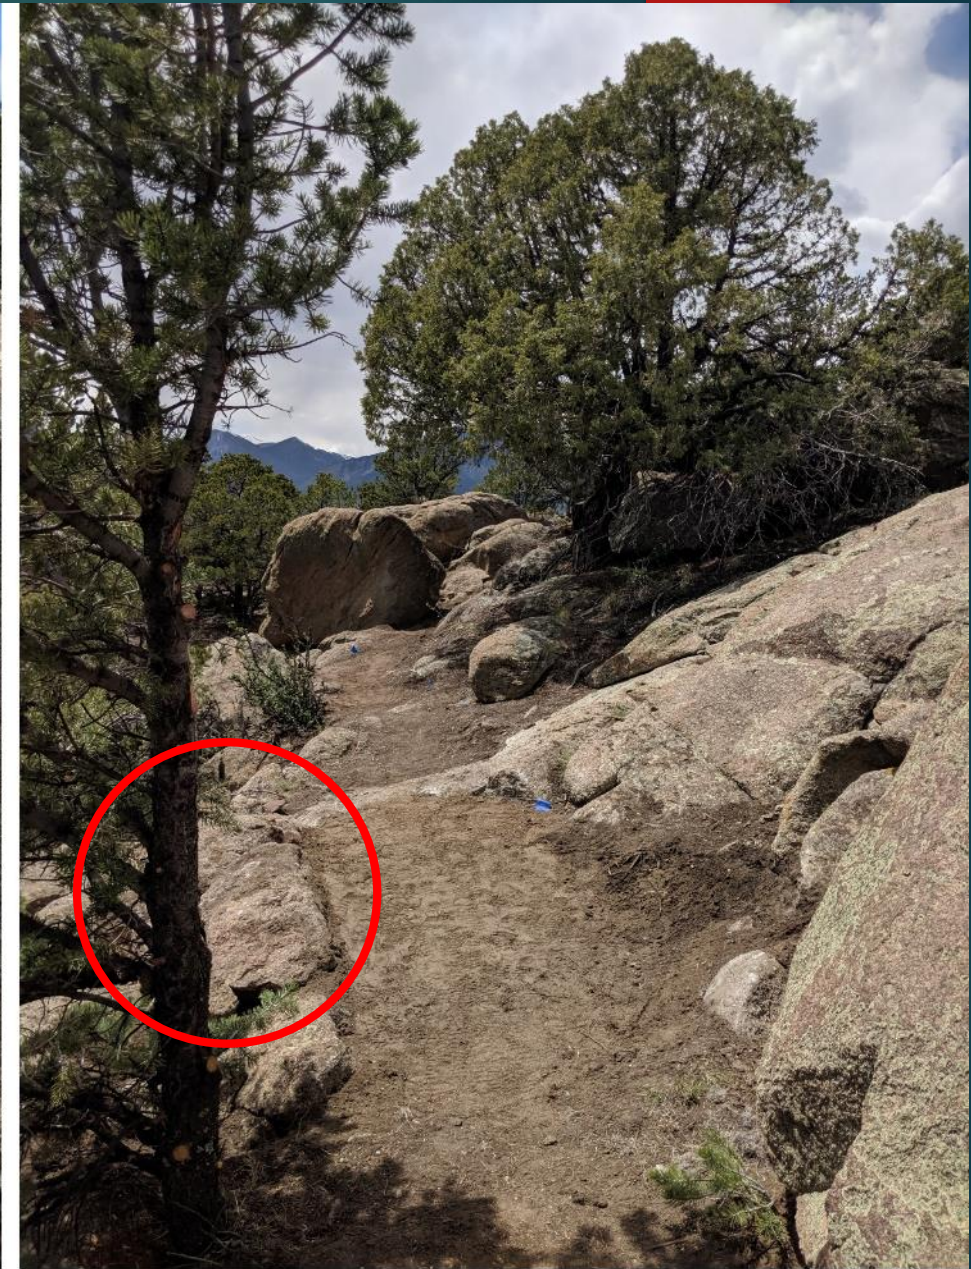
- ▶ Similar to the previous photos, a large rock was moved to make the trail smoother, and it ended up supporting the tread.
