CONSERVATION BEFORE & AFTER PHOTOS 2019

COLORADO MOUNTAIN CLUB
ONLINE UNIVERSITY

Before & After

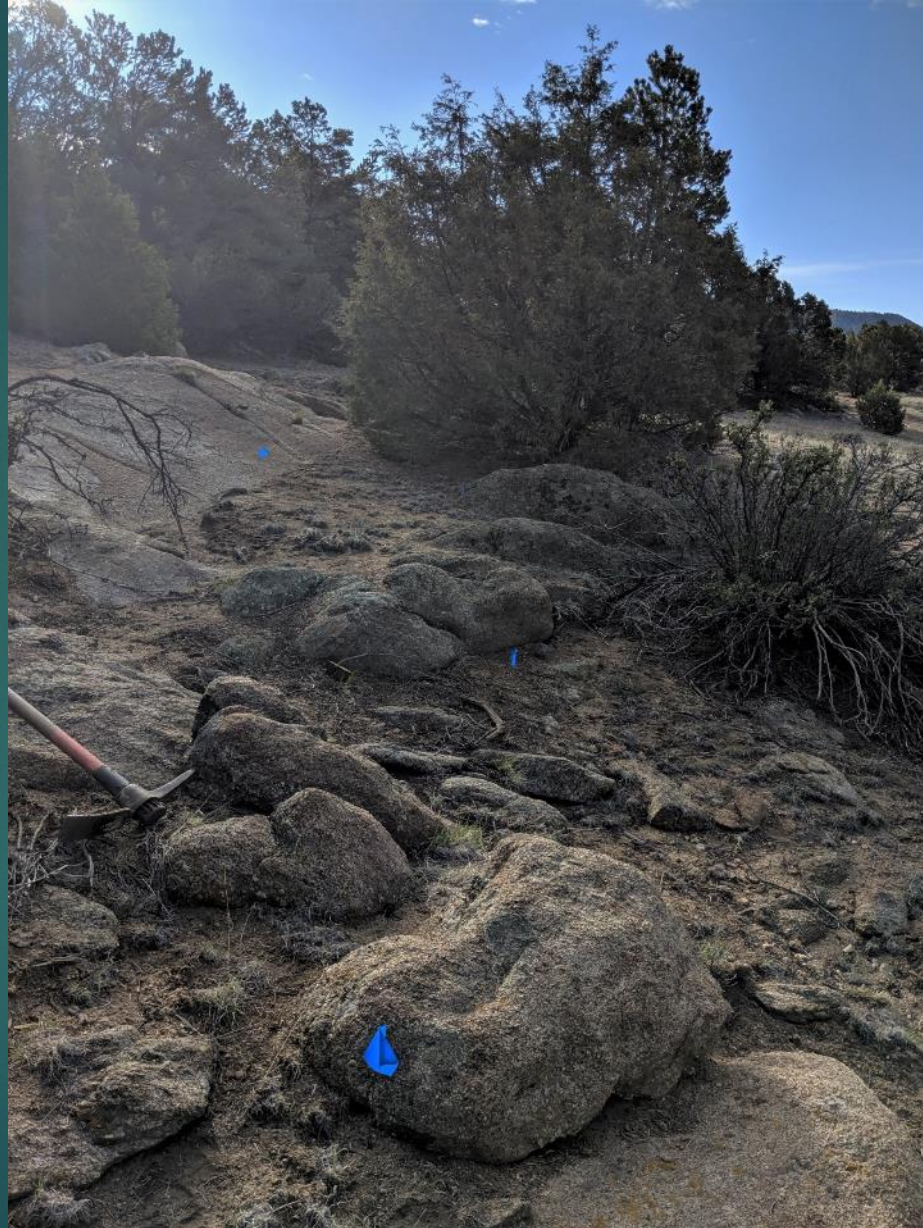
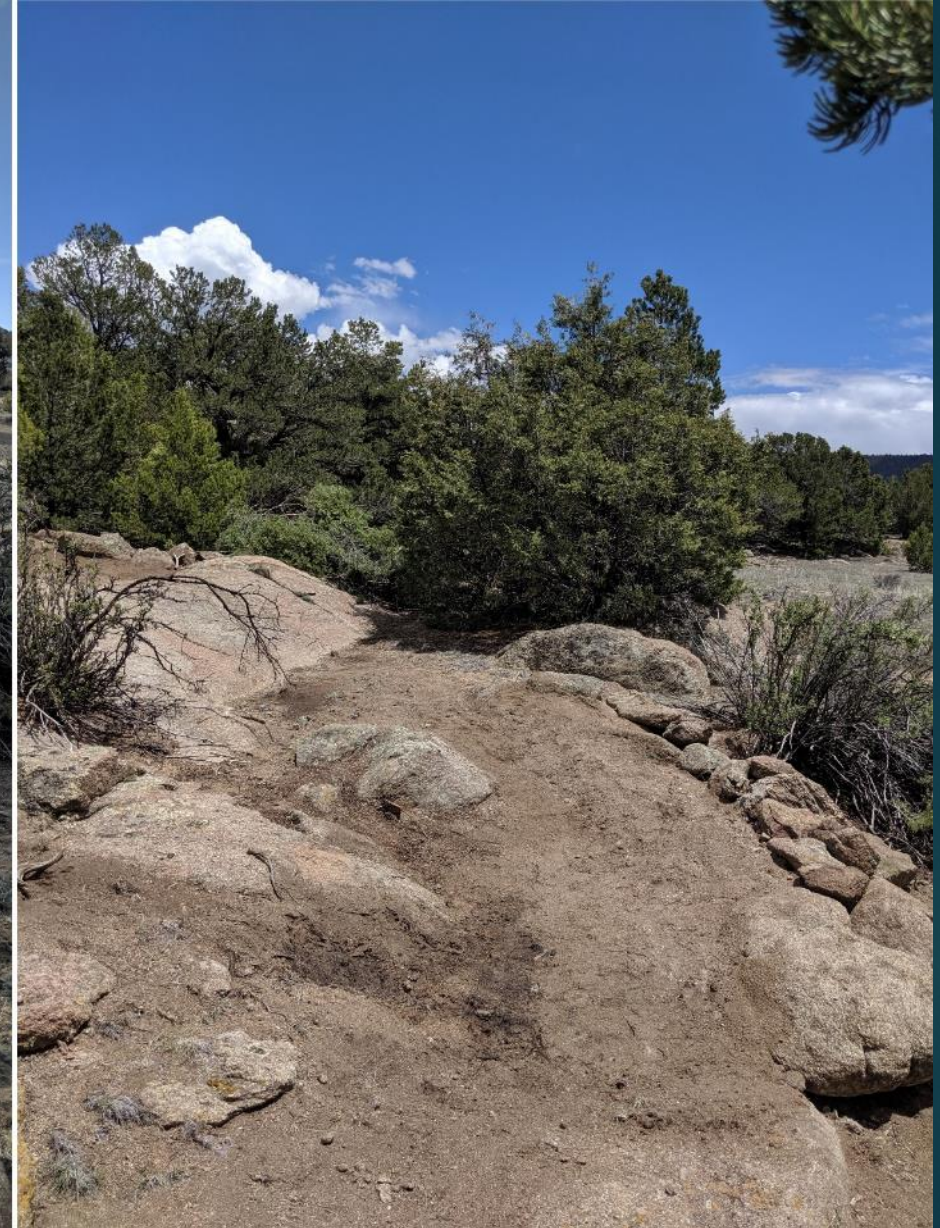
- This picture shows the creation of a bermed turn for a mountain bike trail. All of the rocks seen in the before photo were used as the structure in the berm of the after photo.

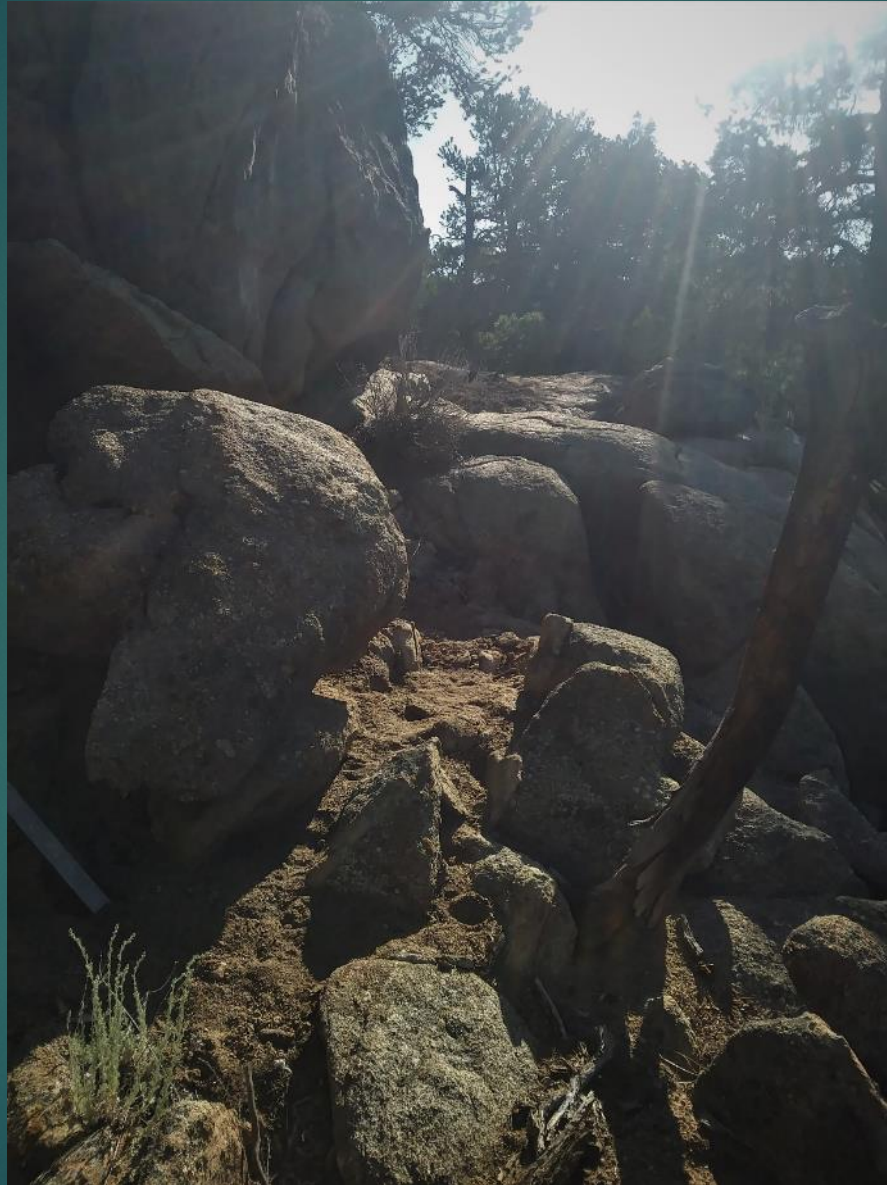
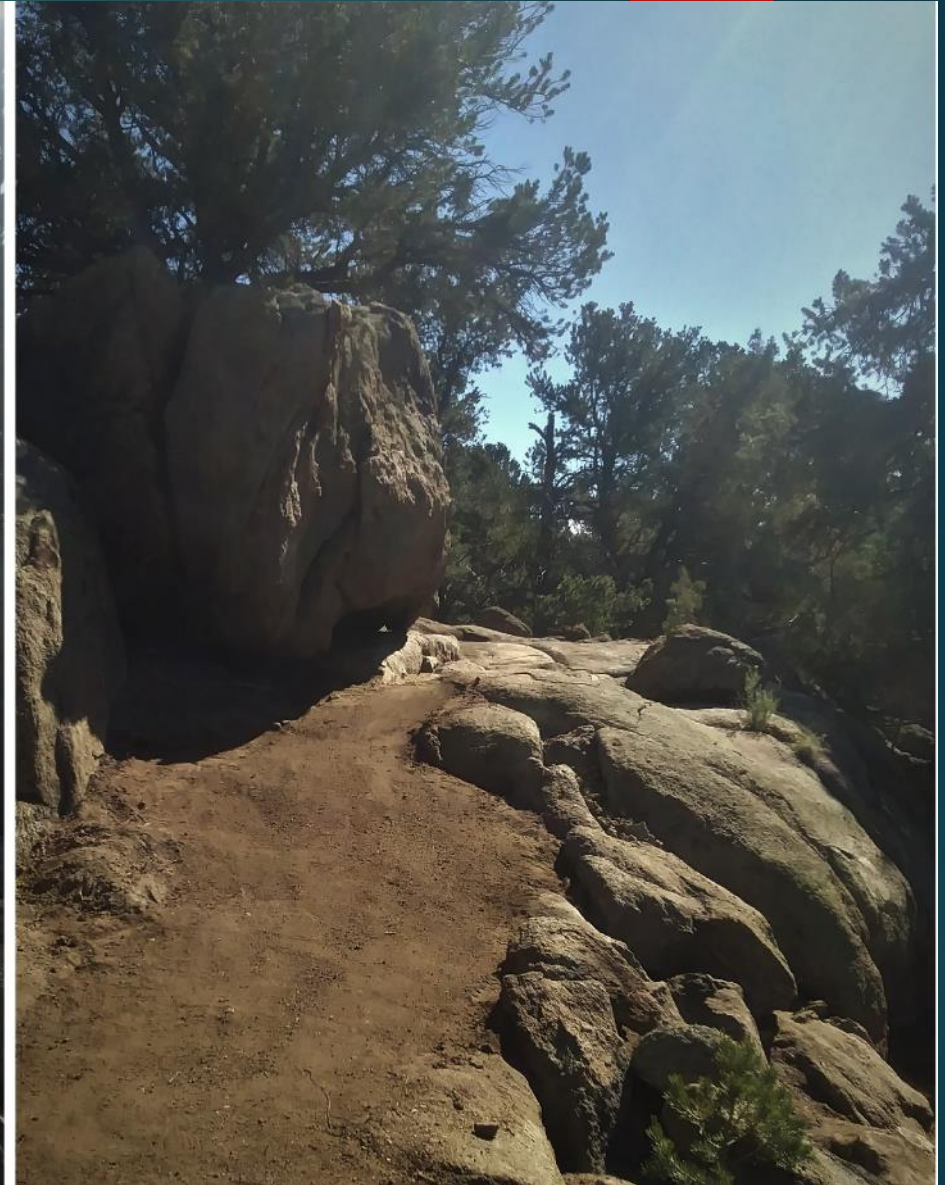
- ▶ This is from new trail construction of the “Unchained” trail near Buena Vista. It demonstrates the amount of work needed to create new trails, especially in rocky terrain.
